**When a major Oil and Gas producer wanted to develop a facility over an unstable subgrade, Contain Enviro Services Ltd provided the design solution to deal with the high degree of settlement experienced on the site.**

## Project Profile: Settlement Detection (SD) Pipe Boots

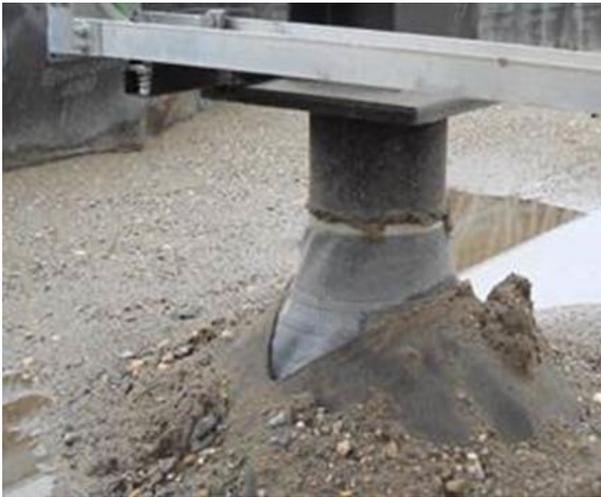
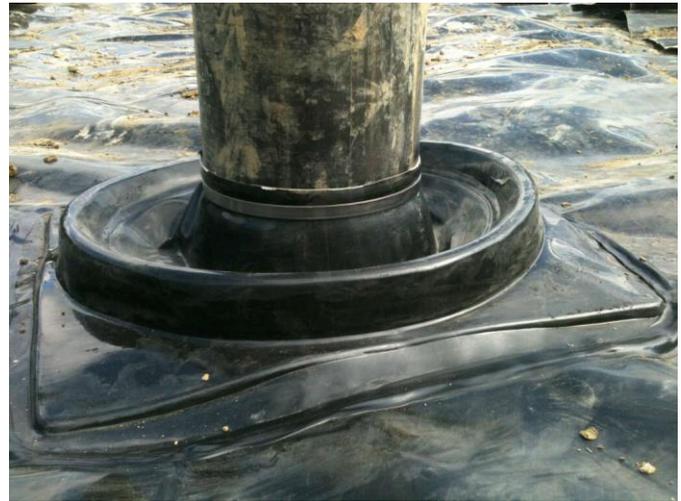
Once the subgrade stabilized and the owner felt that the vast majority of any settlement that the site would experience was over, Contain Enviro's trained installation and maintenance crews returned to site to quickly adjust and reband the Settlement Detection pipe boots at their new elevation. In some areas over 14 inches of settlement was experienced, with all the Settlement Detection pipe boots unique corrugated design performing exactly as per plan.

Contain Enviro Services Ltd suggested the use of Settlement Detection pipe boots for this facility to compensate for the anticipated settlement. A total of 28 Settlement Detection pipe boots were installed in the facility and, as expected, once the spring thaw arrived the site began to settle dramatically. The site was routinely monitored by the facility owner during the spring and summer months to ensure that none of the Settlement Detection pipe boots were allowed to stretch beyond their design limitations.
