## Tech Note: Settlement Detection Pipe Boots

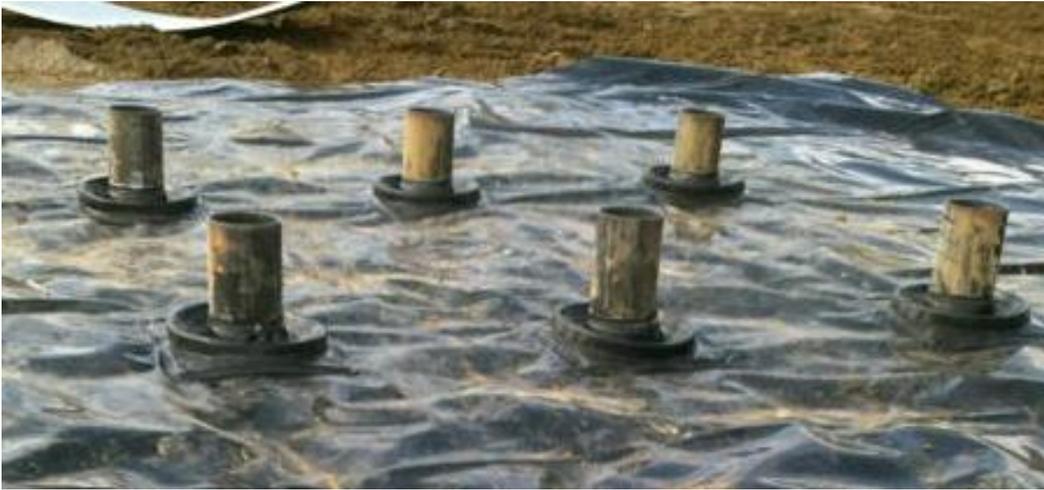
A common design feature of any secondary containment system is the use of posts or pilings to support the tank that will be providing the primary containment. However when this construction technique is utilized, an issue is how to best attach the geomembrane liner to any pilings that now penetrate the geomembrane liner.

Some geomembrane installers will simply pull excess geomembrane up and around the piling, and then clamp this material in place. This construction technique is not utilized by Contain as it is difficult or impossible to create a seal around the piling, as the material is “bunched up” with multiple thicknesses over top of each other, creating a leak path should the containment be called into duty. A more suitable design is the use of prefabricated pipe boots. Prefabricated pipe boots are manufactured by Contain in a variety of dimensions to suit most every style of round post or piling. A prefabricated pipe boot is manufactured to provide uniform thickness around the penetration, so that when properly installed with gasketing and a pipe clamp, a leak-proof seal is created ensuring full containment throughout.

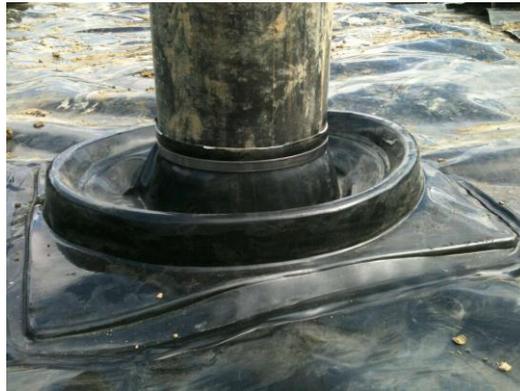
This style of boot has circular corrugations encompassing the main boot section, providing this area the appropriate amount of material to extend downwards should settlement occur. Contain Enviro Services Ltd uses this style of boot on all installations providing a higher level of assurance against unexpected settlement.

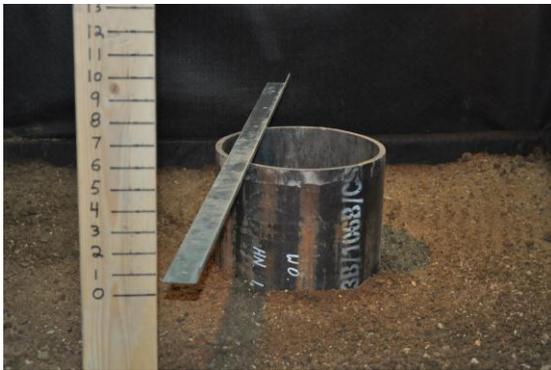
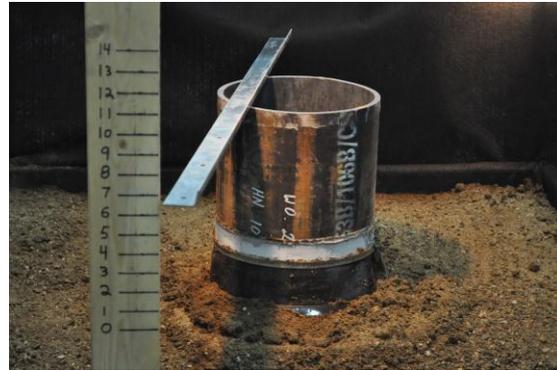
If settlement has occurred and the corrugations have been pulled up, we suggest that have our trained crews correct this deficiency. While the geomembrane in this area is still at its required thickness, this should not be viewed as a permanent solution to the issue.

The installation of pipe boots should be completed before the caps or any cross-members have been welded onto the tops of the metal pilings. However, once the liner and pipe boots have been installed, care must be taken to protect the liner, foot traffic should be minimized, and welding blankets should be placed beneath any areas where welding is required so that sparks or slag do not melt the exposed liner.
